HISTORIC STRUCTURE REPORT

Schooner *C.A. Thayer*

National Park Service | June 2022

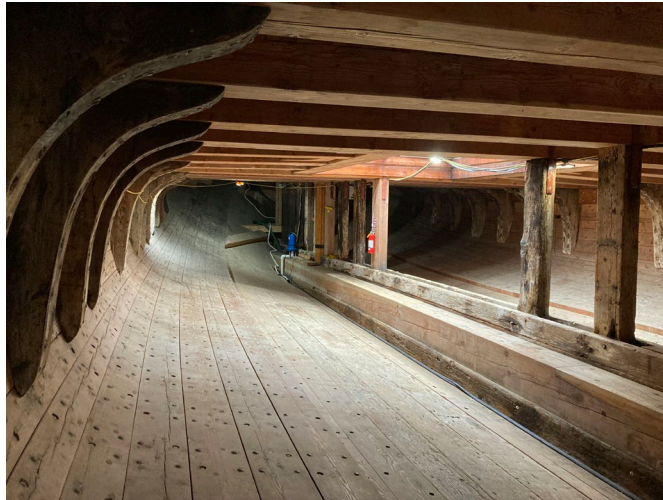
Photo 1. The hold construction is similar to a land-based heavy timber style. This can be difficult to ignite and when ignition does occur, the fire will initially burn along the surface to form a char layer that helps to insulate the timbers from further fire damage. The borate treatment that the Park applies for wood preservation will also function as an intumescent treatment to retard the initial rate of fire spread. The Thayer's hold does not contain a sizable amount of combustible contents that could produce a fast growing fire. The present fire risk is extremely low.

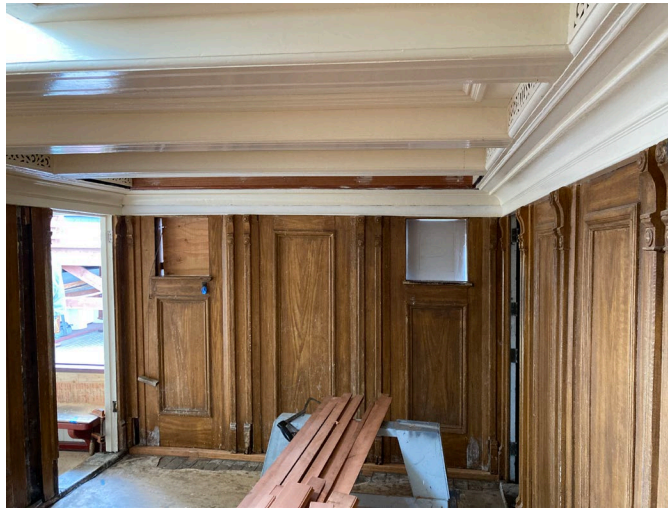
The Thayer's fore and aft deck houses are lighter weight wood construction, comparable to a land based type 5 wood framed construction. If ignited the anticipated fire growth rate is SFPE that if moderate and capable of producing a fire of 30-45 minutes duration. This type of fire could ignite rigging and travel vertically up mast assemblies. The probability of an initial lateral fire spread across the main deck is low but could be increased by burning rigging materials raining down on the decks.

Photo 3: The deck houses are lighter wood framed construction and pose a potential moderate fire growth rate.
